September 3, 2009

**RE: Ketchikan Gateway Borough – Mike Smithers Pool
Roof Observations and Intrusive Inspections**

Trinity | ERD received a commission from Ketchikan Gateway Borough to carry out an inspection and an infrared scan of the composition shingle roof at the Mike Smithers Community Pool ('the Pool') located in Ketchikan, AK. Trinity | ERD was informed that the Pool was re-roofed in 1999. At the time of the re-roof, an addition to the pool structure was constructed at the northeast elevation of the building.

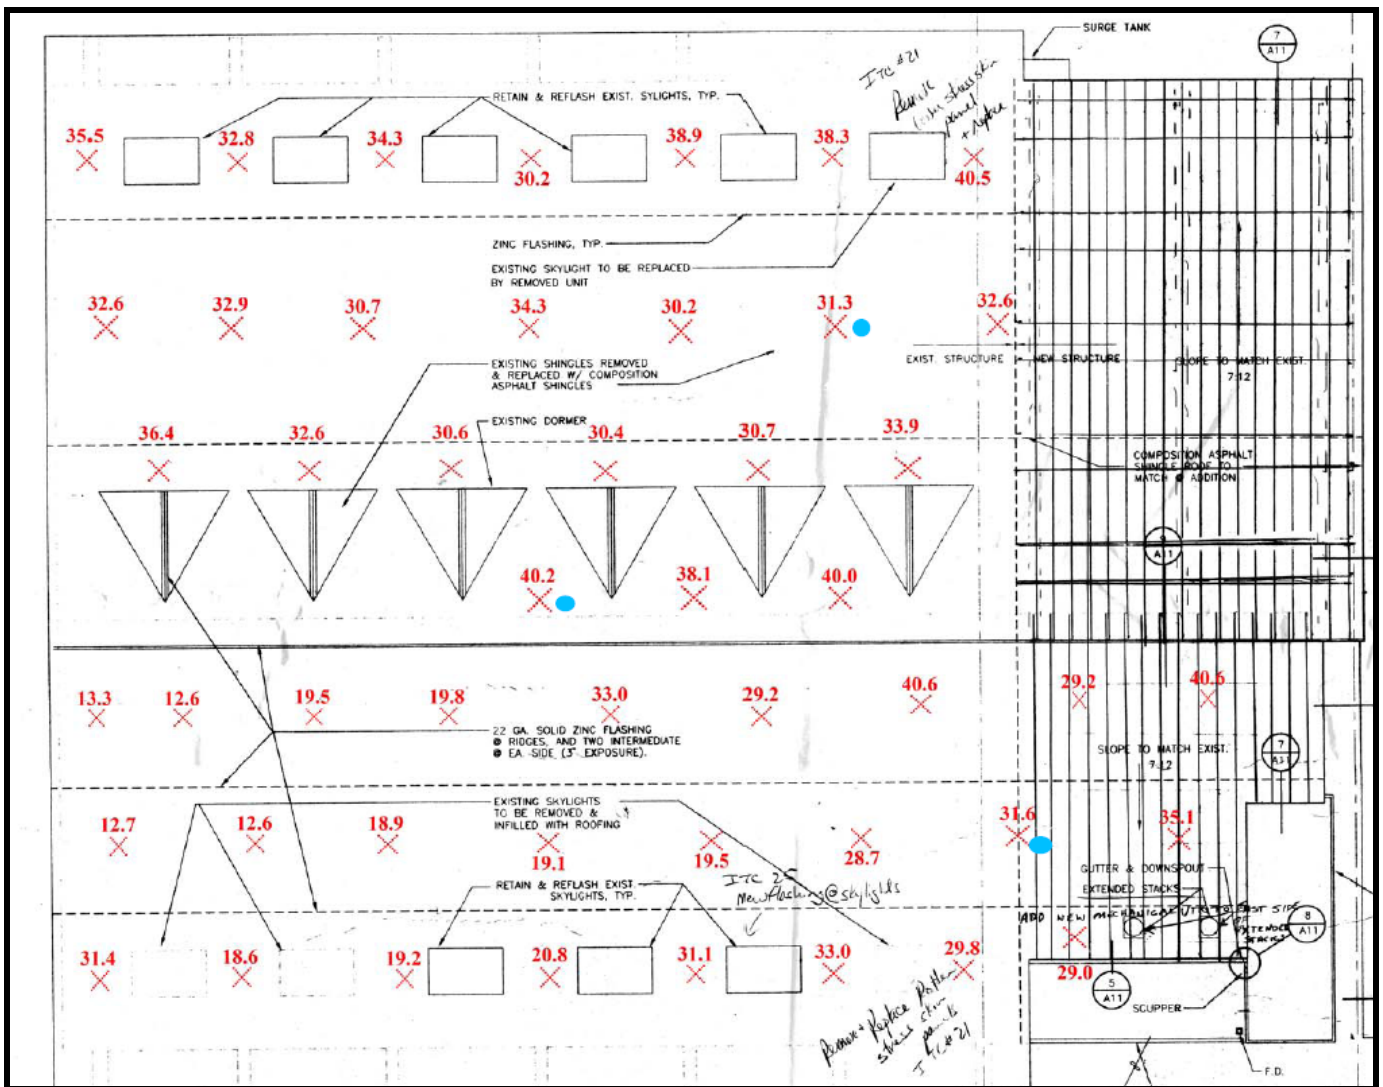
Figure I – Roof Map Showing Moisture Meter Readings (Red X's) and Roof Cut Locations (Blue Dots)

Moisture readings taken within the OSB sheathing and plywood surface of the composite panels were taken with a TRAMEX MRH moisture meter. Twenty-four readings were taken on the North and South planes of the roof. Readings were taken in the top surface of the OSB sheathing and the top surface of the plywood panel. The moisture readings are marked on the roof plan below, along with the locations of test cuts in the roof. In summary, the OSB and composite panels are consistently wet throughout the roof area.

Three intrusive cuts were made in the roof assembly, at the locations identified on the roof plan above. Only one sample was retained from these cuts; at the other two locations, the materials removed simply crumbled during removal and were no longer suited for further analysis due to their advanced state of deterioration.

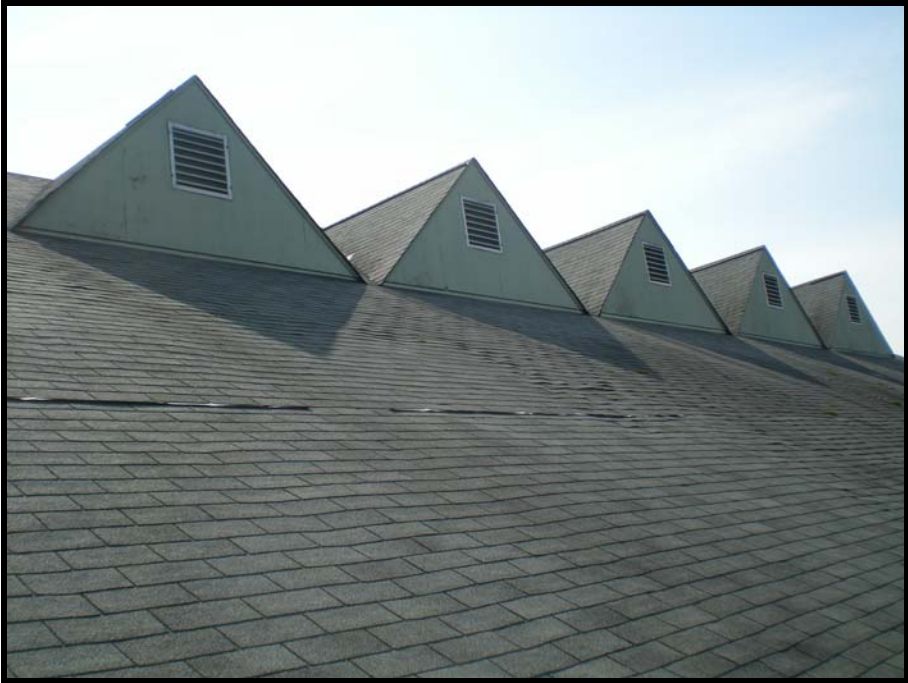
Inspection of the North face of the roof revealed OSB sheathing that is decayed, soft and swollen. Foot traffic completely breaks up the OSB surface. The structural integrity of the OSB sheathing has been compromised by water and can no longer hold the shingle nails. Shingles pull away and slide under light pressure. The roof assembly and substrate have failed. The bond of the composite material has also failed in many areas observed, impacting the structural loading capabilities of the decking assembly.

Photo- 1 Overview of the North Roof

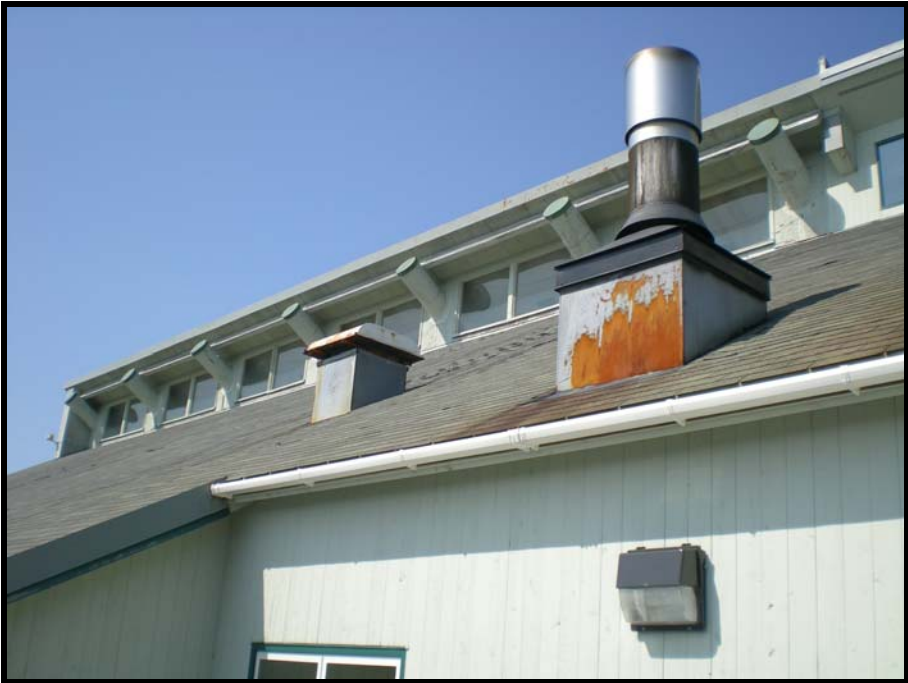
Conditions are similar on the South face of the roof. The East half is particularly wet. Shingles removed in this area revealed severely decayed, soft, and swollen OSB sheathing. Again, areas of sheathing gave way under foot traffic.

Photo- 2 Overview of the South Roof

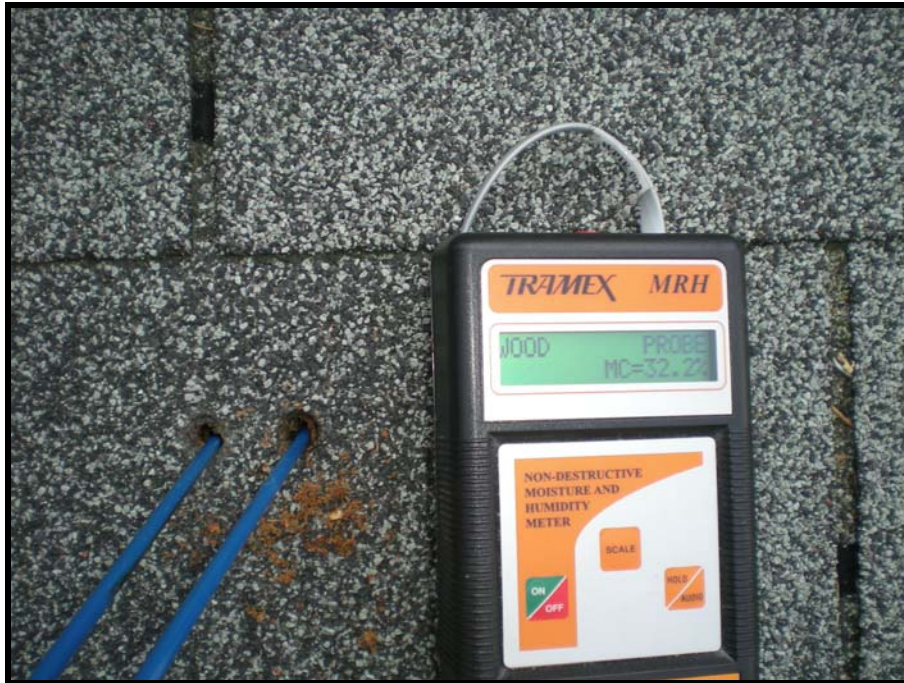
Photo- 3 TRAMEX Moisture Meter Reading of the Plywood Surface Taken at the Top Surface of a Composite Panel - 32.2%

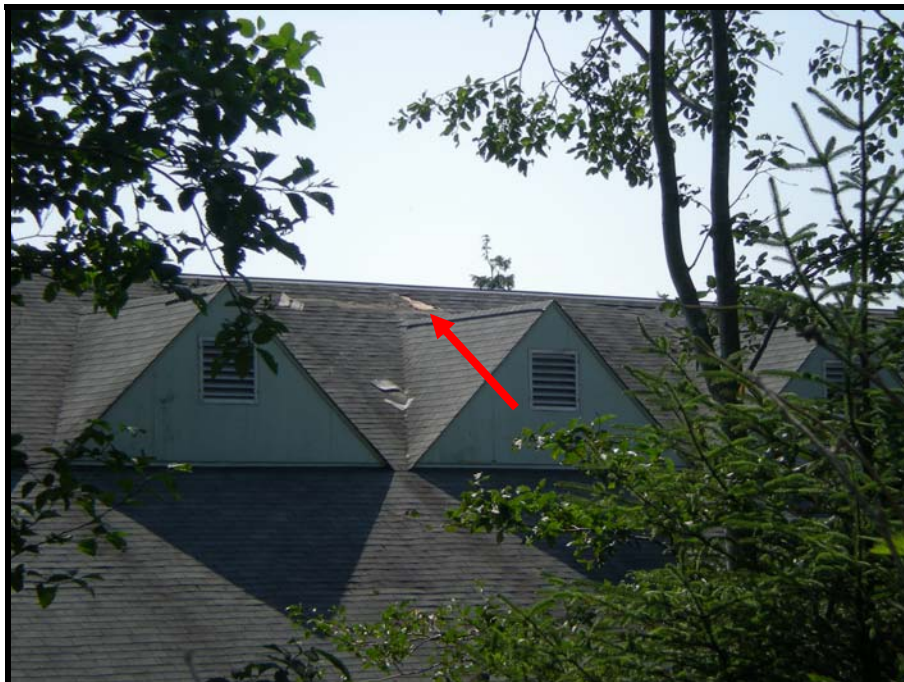
Photo- 4 Example of Area of Exposed OSB Sheathing

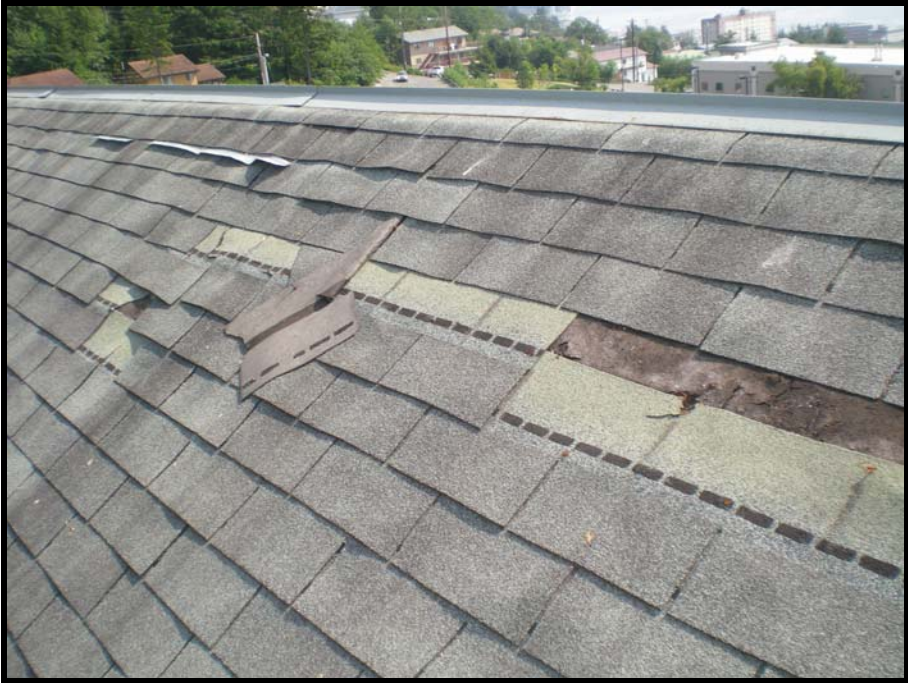
Photo- 5 Example of Missing and Damaged Shingles

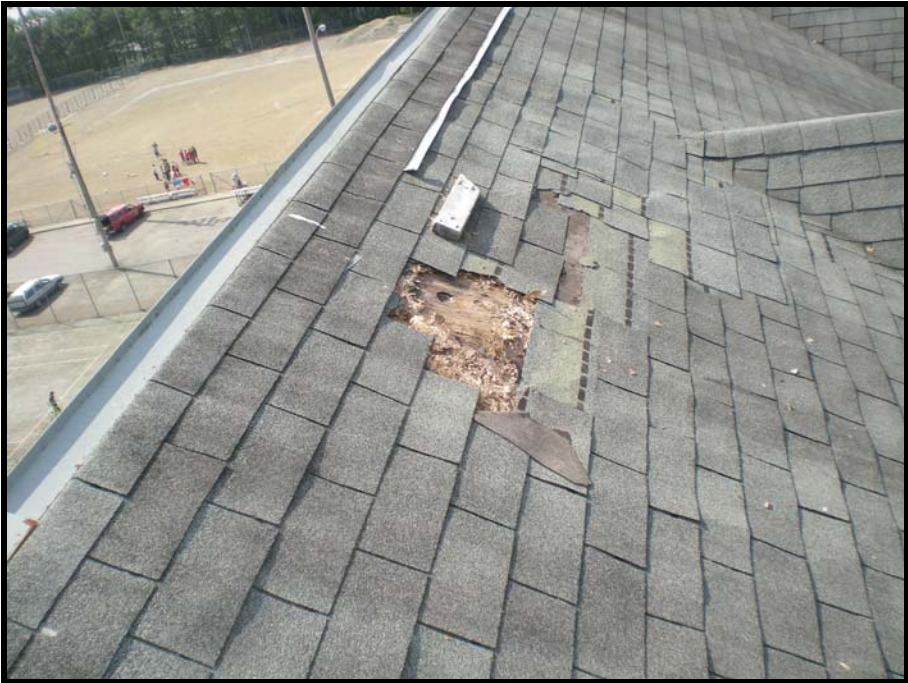
Two areas of exposed, decayed plywood on the composite panels were observed during the inspection. In these areas, the shingles have either blown off, or been pulled off, and the OSB and plywood sheathing has completely decayed, exposing the insulation. Maintenance personnel conveyed that all that can be done to temporarily repair these areas is to cover the exposed area in roofing mastic and stick shingles in place. This type of repair provides minimal protection and can be a danger for any foot traffic.

Photo- 6 Example of Bird Damage Resulting in Exposed OSB and Plywood

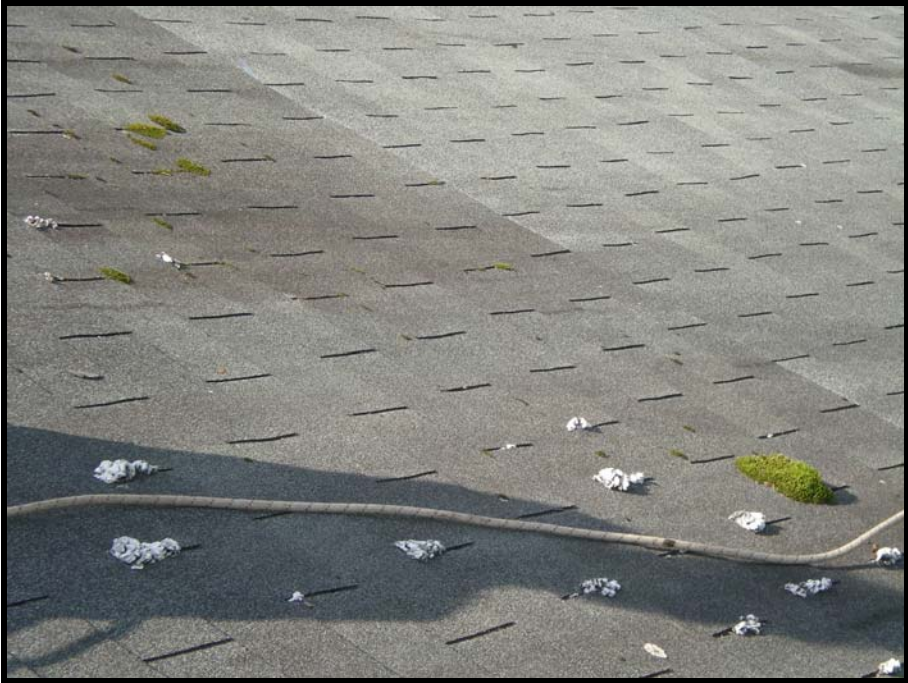
Photo- 7 Example of Moss and Mushroom Growth

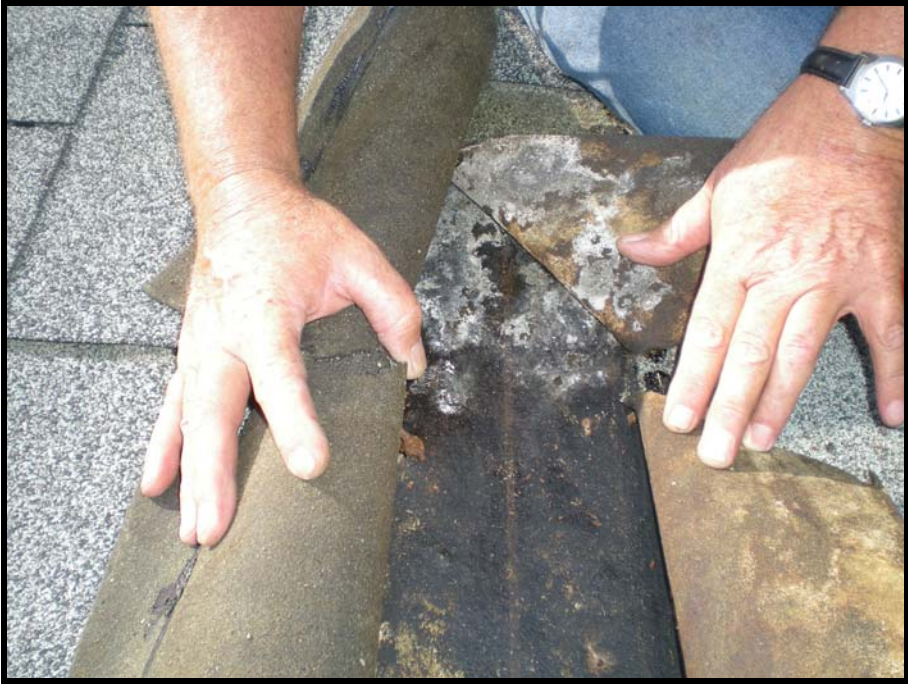
Photo- 8 Shingles Lifted Revealing Wet Roofing Felt

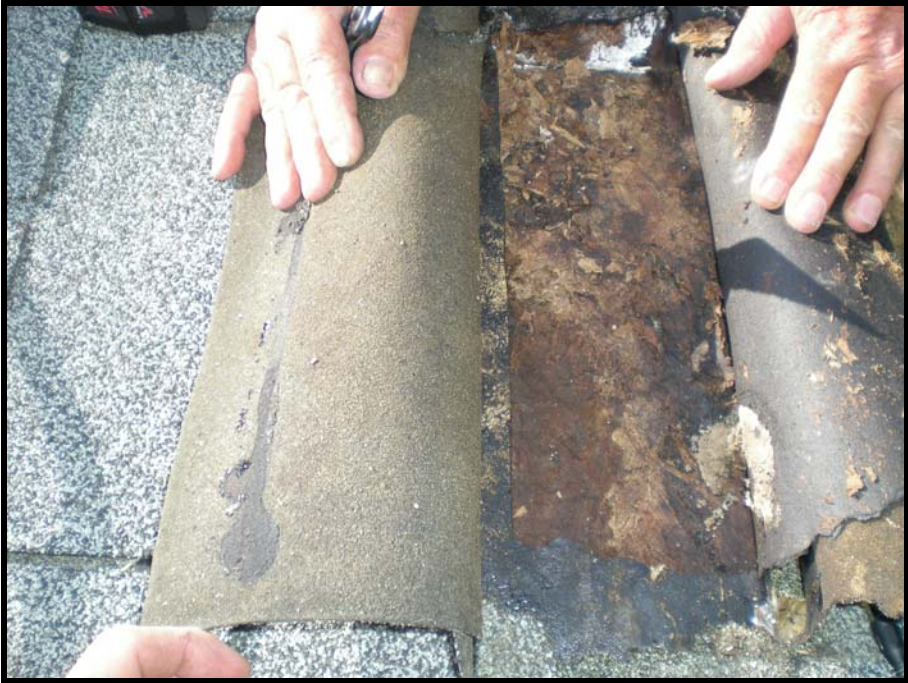
Photo- 9 Shingles Lifted to Expose Wet and Decayed OSB Sheathing

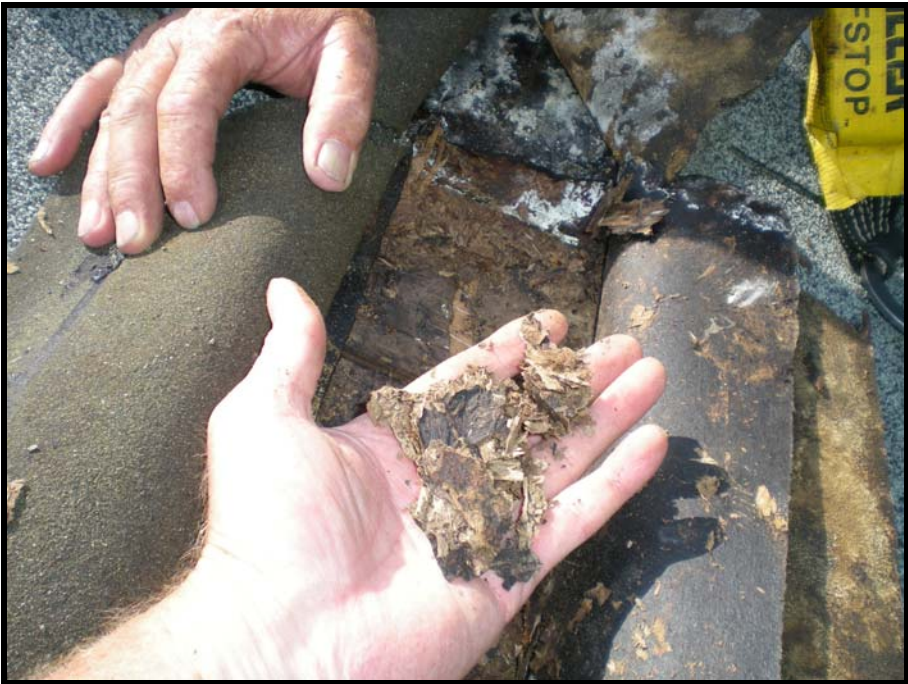
Photo- 10 Decayed and Flaking OSB Sheathing

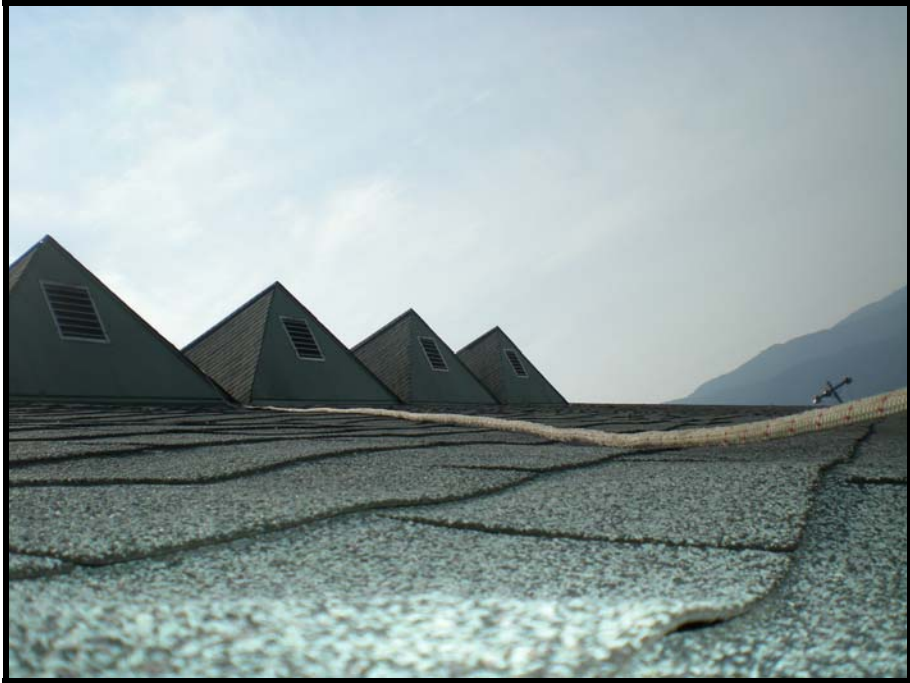
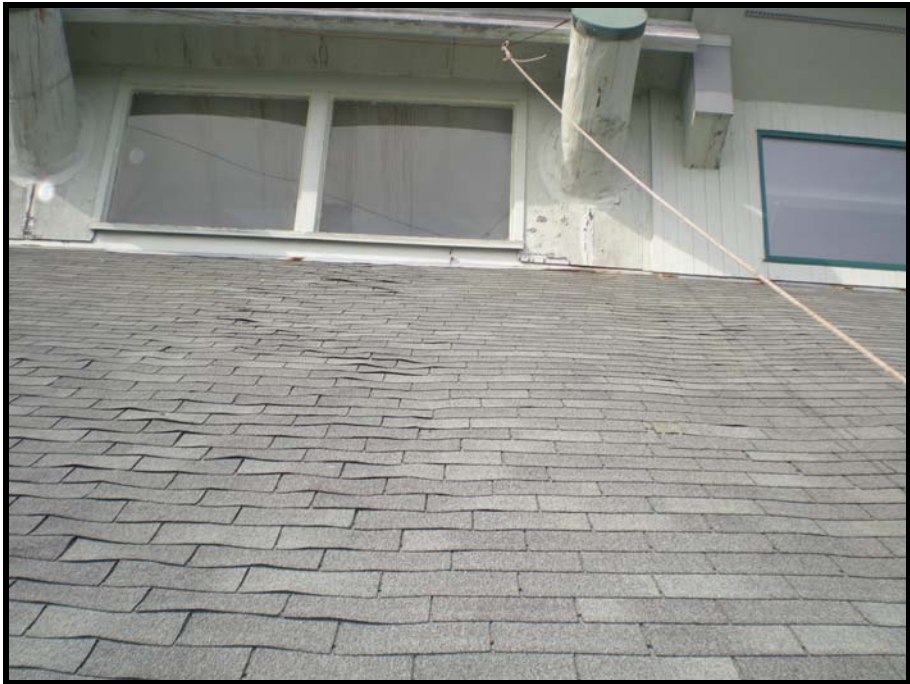
Photo- 11 Roof Deflection as a Result of Decayed and Deformed OSB Sheathing

Photo- 12 Roof Deflection as a Result of Decayed and Deformed OSB Sheathing

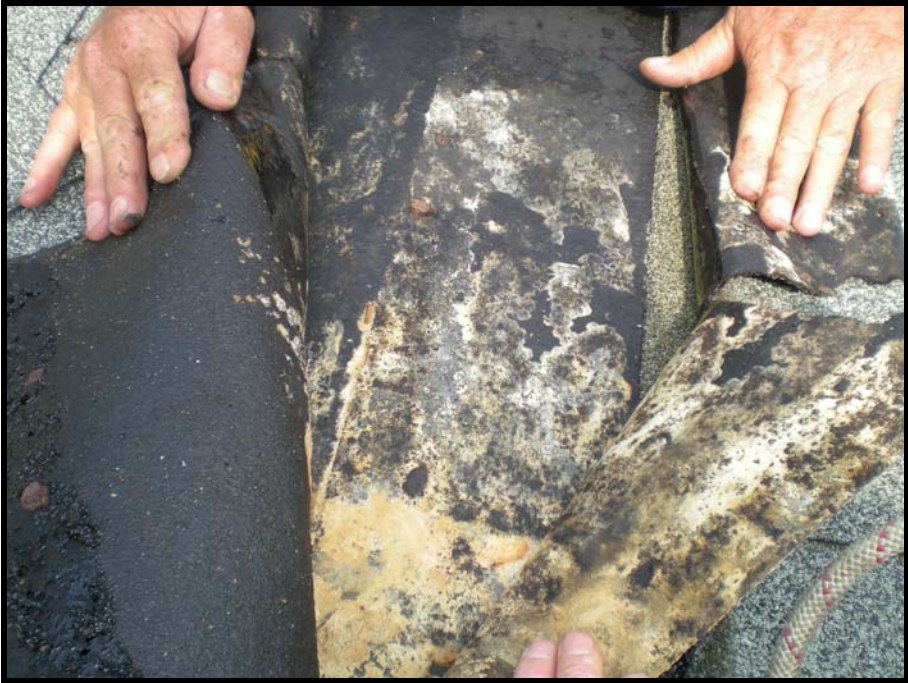
Photo- 13 Organic Growth Between Shingles and Roofing Felt

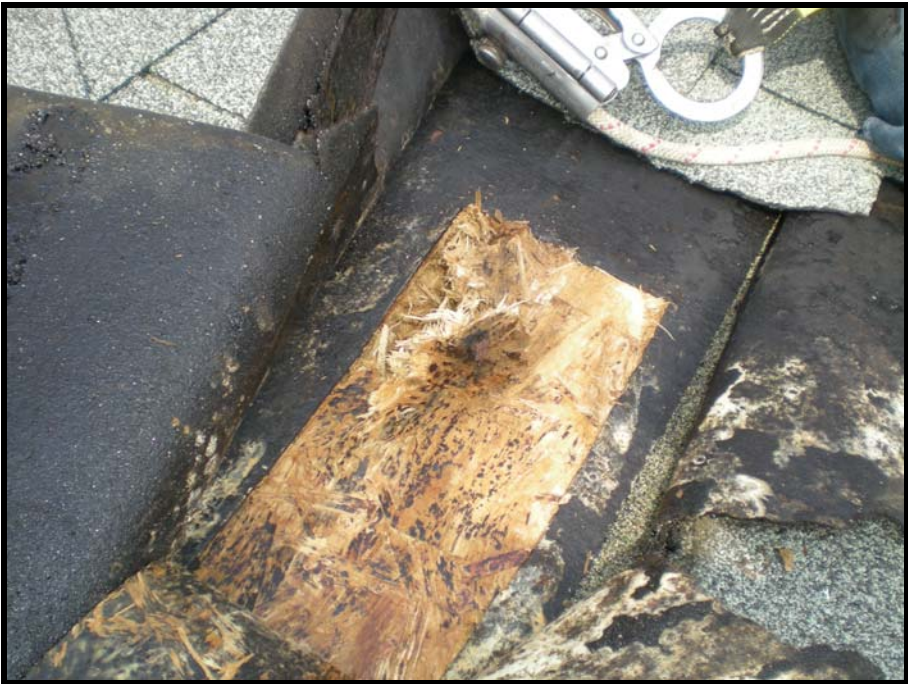
Photo- 14 Organic Growth Between Roofing Felt and OSB Sheathing

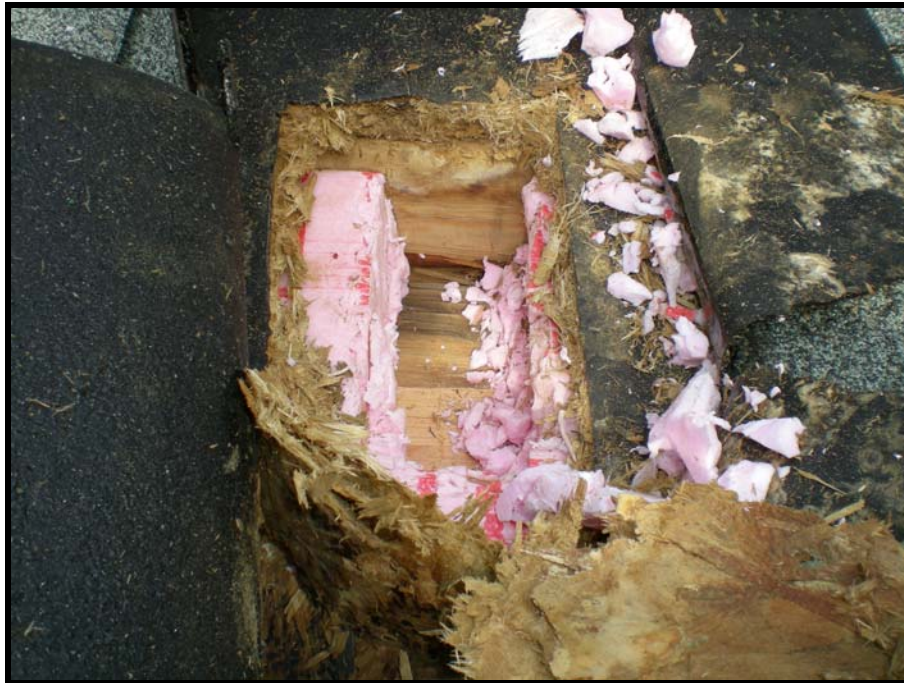
Photo- 15 Intrusive Opening in Composite Panel Revealing Wet Plywood and Extruded Polystyrene Insulation – This Area is Assumed to be a Repair Based on the Change in Insulation, the Materials Replaced do not Form a Composite

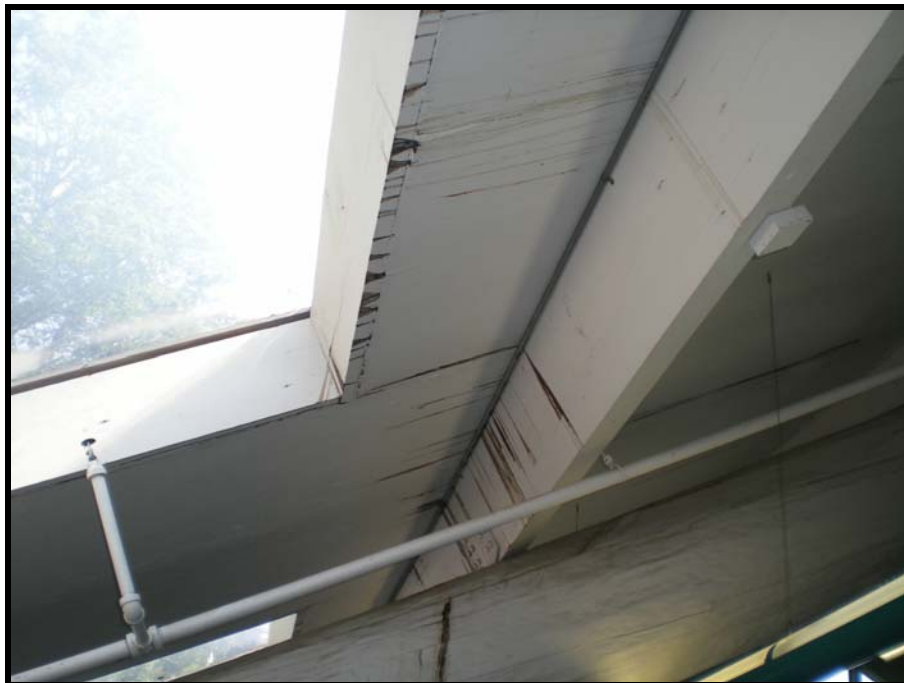
Also noted in the interior were significant cracks in the log beam framing of the roof. In addition, there is severe blistering of the interior paint at the transition between the original building and the addition. Leaks are evident at dormers as a result of water running under the underlayment by passing the flashings at the roof-to-wall transitions.

Photo- 16 Leakage Observed in Dormers on South Face of Roof

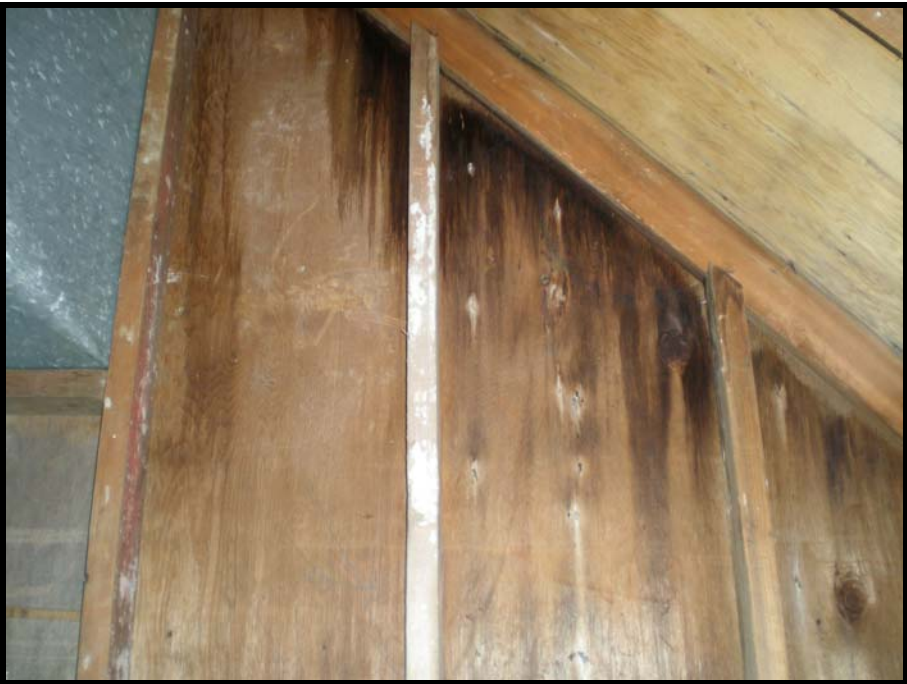
In the interior of the building, there is evidence of moisture running down the plywood walls on the interior side of the vent dormers. Significant water staining was observed at these locations. It was noted that the mechanical unit draws air from the interior and exhausts the air to the exterior through these vents.

Photo- 17 Water Staining on the Interior of the Dormer Housing the Mechanical Vent

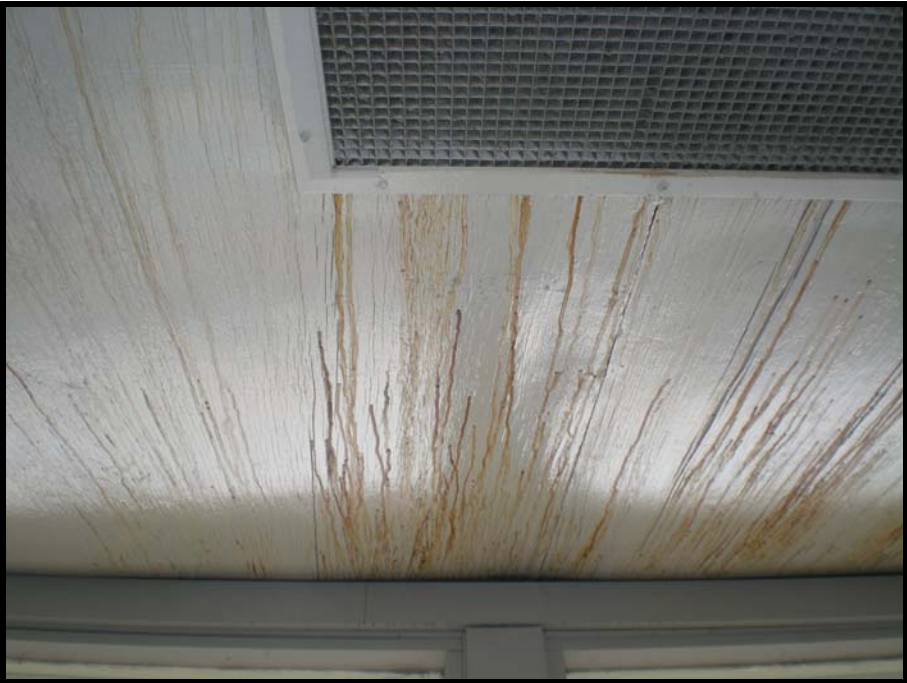
Photo- 18 Leaking and Staining at and Around an Interior Vent

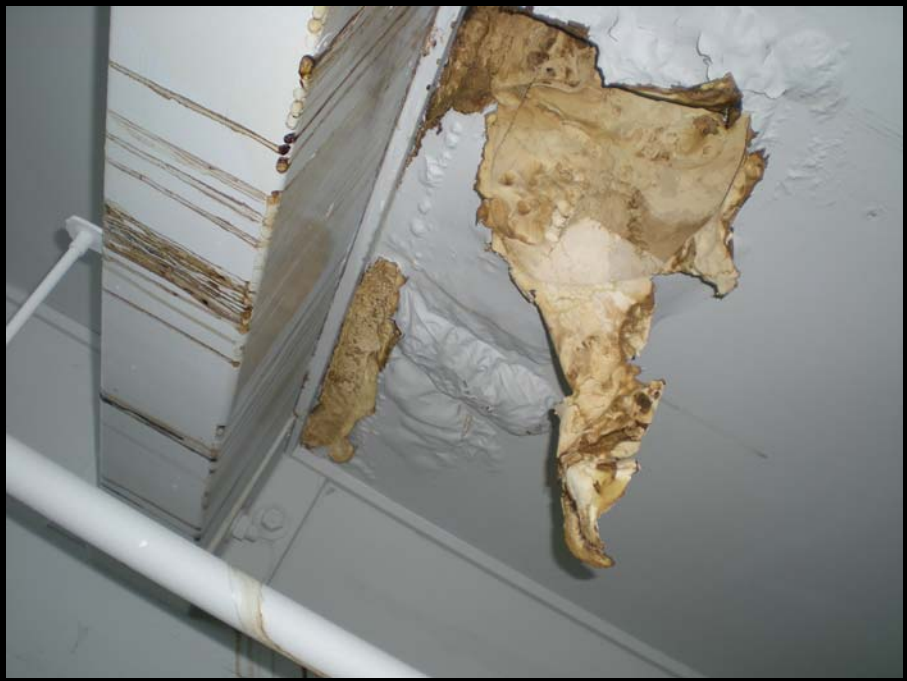
Photo- 19 Paint Blistering at the Transition Between the Addition and the Existing Building

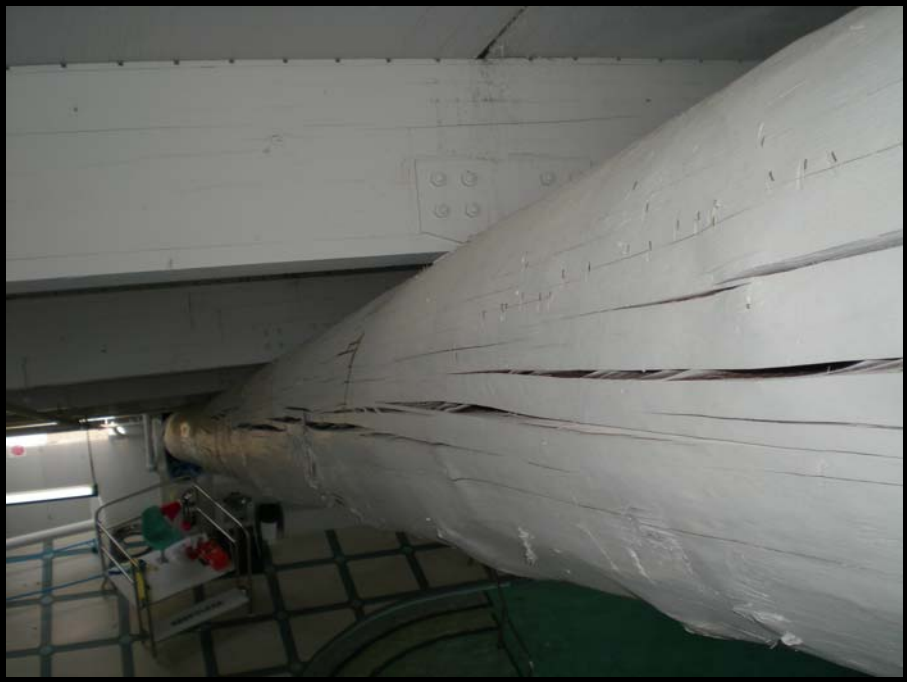
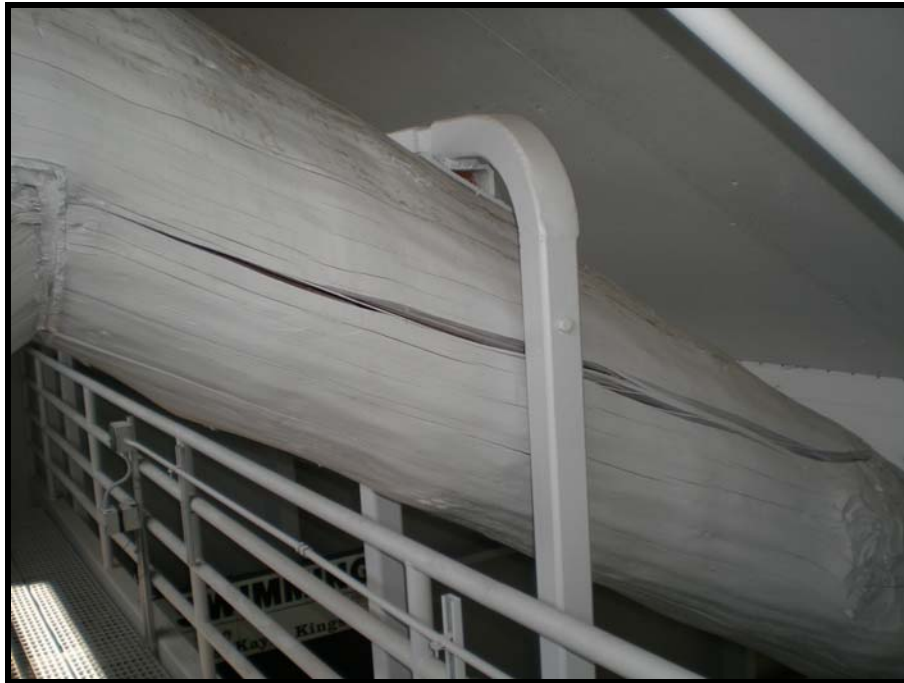
Photo- 20 Example of Cracking of the Log Beams

Photo- 21 Example of Cracking of the Log Beams

Additional structural investigation of the log beam framing is strongly suggested to evaluate the impact of the cracks over the service life of the structural members. It may well be the log beams are over-designed for the anticipated load bearing; however, this should be confirmed.

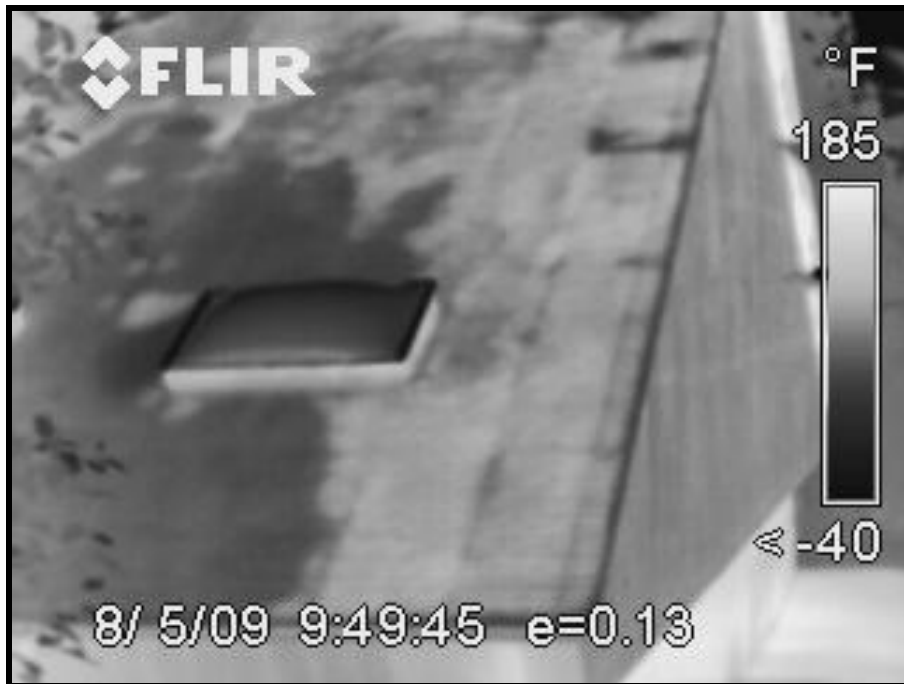
Both the North and South faces of the roof revealed significant evidence of moisture within the roof assembly when viewed with the infrared camera. Moisture levels were consistently high across the entire roof plane. The roof protecting the addition did not reveal any significant moisture accumulation. Moisture accumulation within the main roof is clearly significant as evidenced by these results.

Figure 2 Infrared Photo of Northwest Corner of the Roof

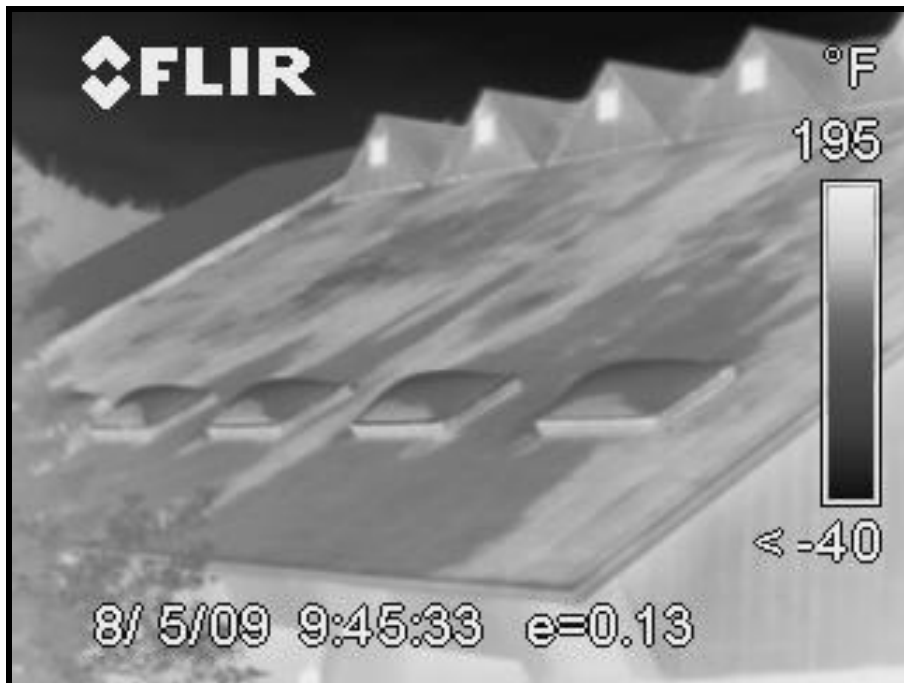
Figure 3 Infrared Overview of North Elevation

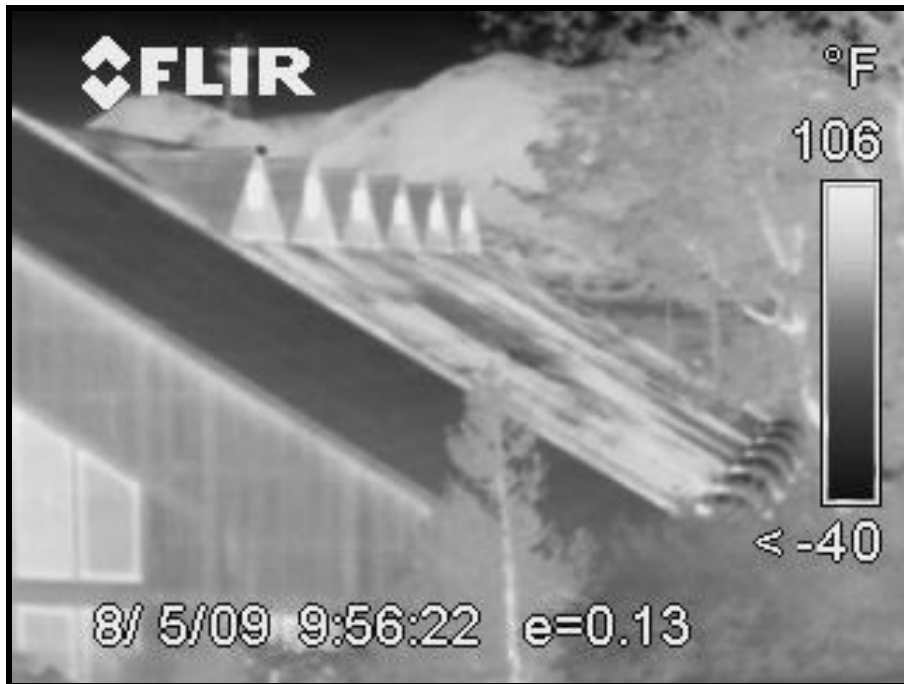
Figure 4 Infrared Overview of North Elevation – Note Addition Roof is Dry

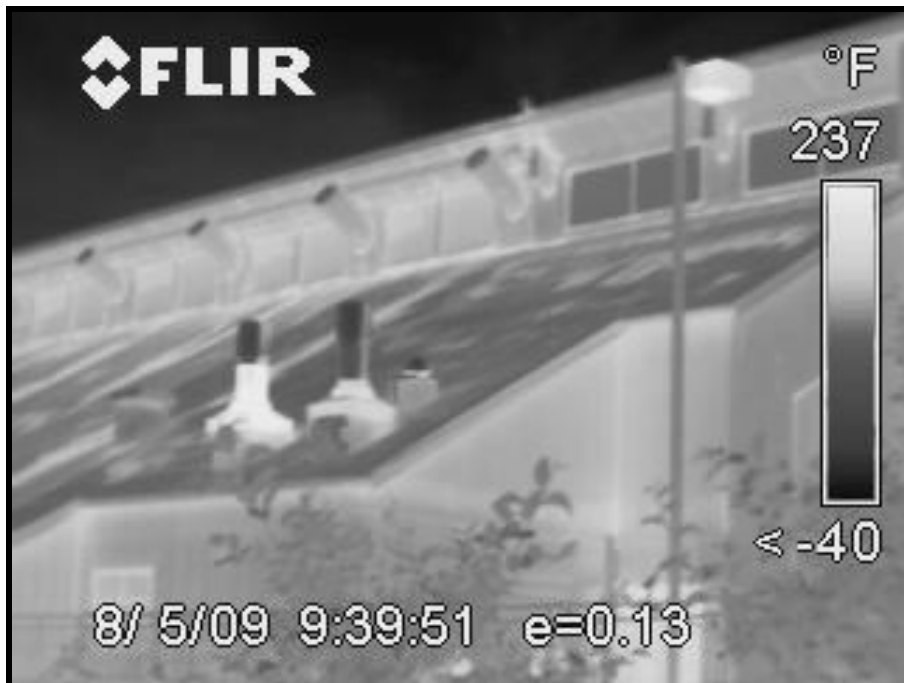
Figure 5 South Elevation Roof Above the Boiler Room

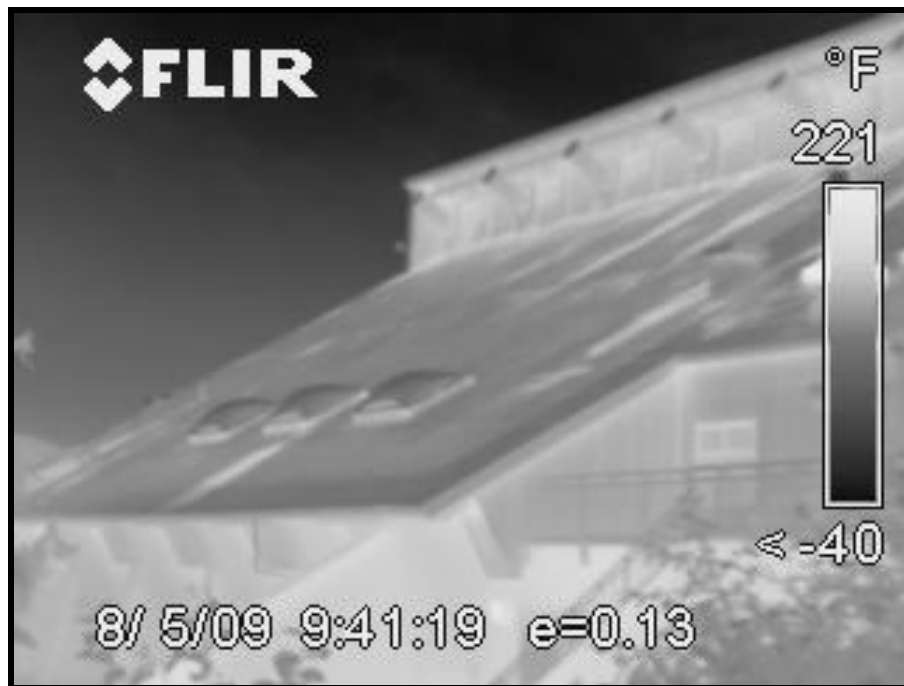
Figure 6 Infrared Photo of Southwest Area of Roof
