September 3, 2009

**RE: Ketchikan Gateway Borough – Mike Smithers Pool
Roof Observations and Intrusive Inspections**

Trinity | ERD received a commission from Ketchikan Gateway Borough to carry out an inspection and an infrared scan of the composition shingle roof at the Mike Smithers Community Pool ('the Pool') located in Ketchikan, AK. Trinity | ERD was informed that the Pool was re-roofed in 1999. At the time of the re-roof, an addition to the pool structure was constructed at the northeast elevation of the building.

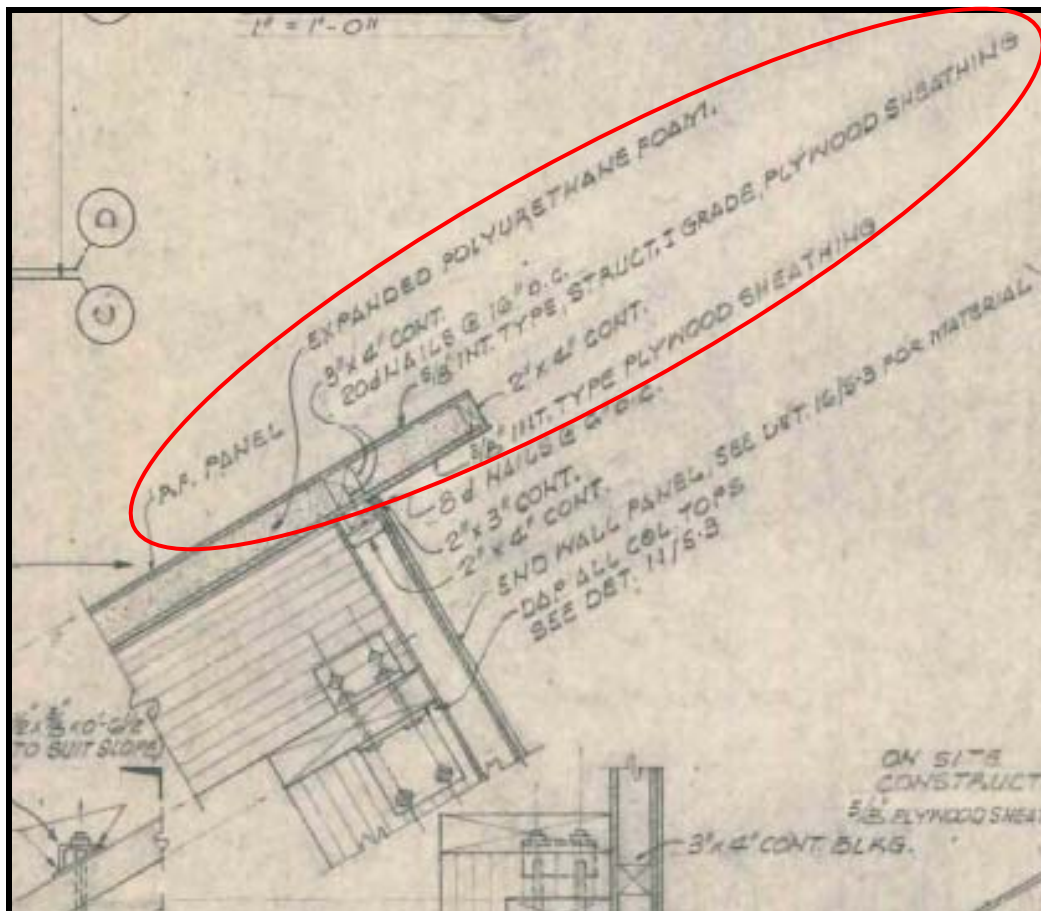
Figure 7 – Detail 3 on Sheet S3 of the Structural Plans

This panel is an ‘early day’ example of Structural Insulated Panels (‘SIPS’), which were first designed using polyurethane foam. They became common in engineered post and beam homes and recreational structures such as natatoriums. Panel manufacturers subsequently changed to the use of expanded polystyrene to form the core for a variety of technical reasons. The Structural Insulated Panel Association (‘SIPA’) only publishes data for expanded polystyrene core panels.

The bonds between the three components, forming the composite, are critical to the structural performance of the panel. The capabilities of the panel to resist loads is dependent on the bonds between all three elements. The loss of bonds and the deterioration of the top plywood panel have greatly reduced the load bearing capabilities of the panel. The load tables below show the standard allowable loading for SIPS panels as provided in the NTA Evaluation Report commissioned by the SIPA in 2009. Note these tables do not directly represent conditions on the project; however, they provide a general view of performance when the components are fully laminated.

The report provides loading values for a variety of panel thicknesses. Based on the detail above, the composite panels were approximately four inches thick. The closest thickness the report provides is 4 5/8 inches thick, which is relatively similar, but not exact to the industry

It is strongly recommended that a structural analysis be carried out as soon as practical to determine the current structural capabilities of the composite panels and the ability to carry anticipated snow loads this coming winter.
